This post is intended to give a quick look at the hardware setup for the 60<sup>th</sup> Anniversary Made With Magic ear hats. I don't have the capability to really dig into the details of the various components nor their connections. But, hopefully, this presentation will shed a little light on the changes that have been made between this model and the previous model that was described on the Mulluzi Labs page at <https://08milluz.wordpress.com/2013/11/11/glow-with-the-show-ears-teardown/>

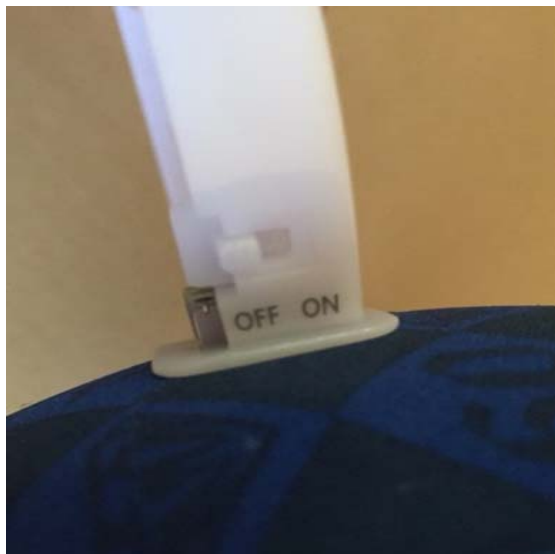
The first difference that was noted is the location of the on/off switch. It's now on the outside of the cap on the bottom edge of the right ear instead of being inside the top center of the cap. This is much more convenient while wearing. You don't have to take the cap off to control the power to the ears. Nice change:

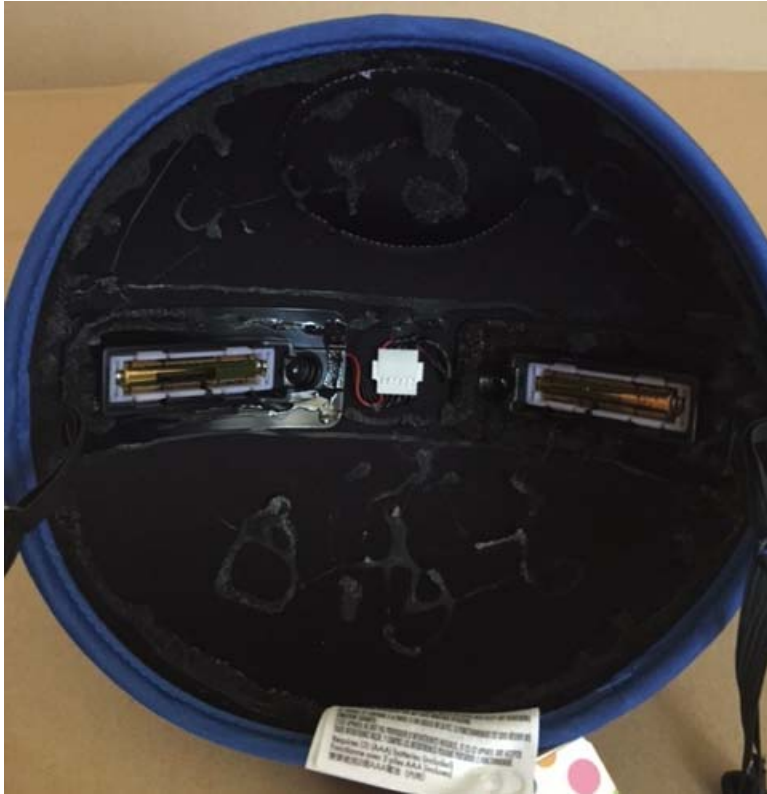
If you are used to the on/off switch being inside the cap and looked there first, you'd notice another change in design – there are now two battery compartments, one directly beneath each ear; there is a new wire connecting the batteries and no sign of a main circuit board. In this view, the black foam liner has already been removed. The connector is not visible without removing the foam liner and the battery compartments have black plastic covers that have been removed for this photo:

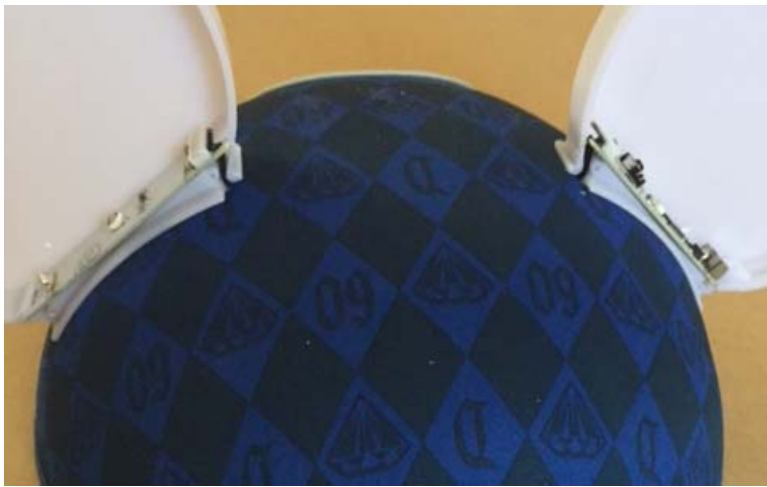
The circuit boards have been moved to inside the ears, one board in each ear. For this photo, the white plastic backs of the ears have been popped off to reveal the boards:

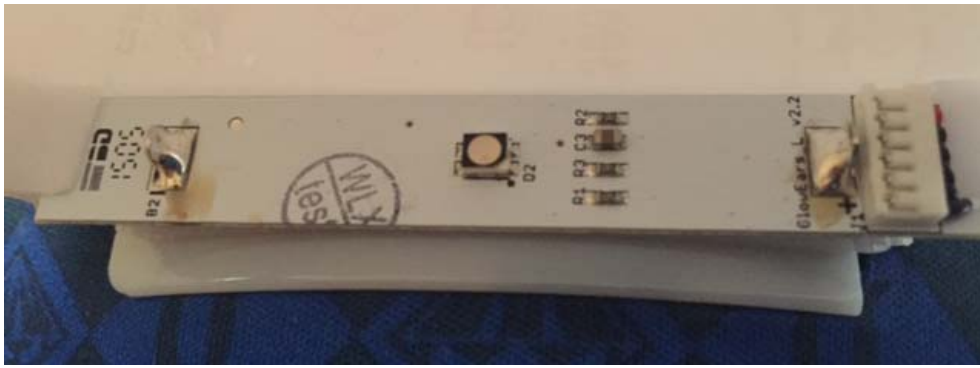
The board in the left ear mostly contributes one LED:

The label indicates this is GlowEars version 2.2. Those large soldered posts connect all the way through to the battery terminals in the compartments beneath. To release the board, those connections have to be desoldered. I couldn't come up with a way to manage that without pretty much destroying the hat. These devices are meant to remain 'as is'. Given that the dang thing doesn't fit my head at all, I didn't mind doing a destructive tear down, but it's good to know about this if you are one who likes to repurpose the components and hope to possibly reassemble back to the original in the future. This is probably not a good choice for such strategies.

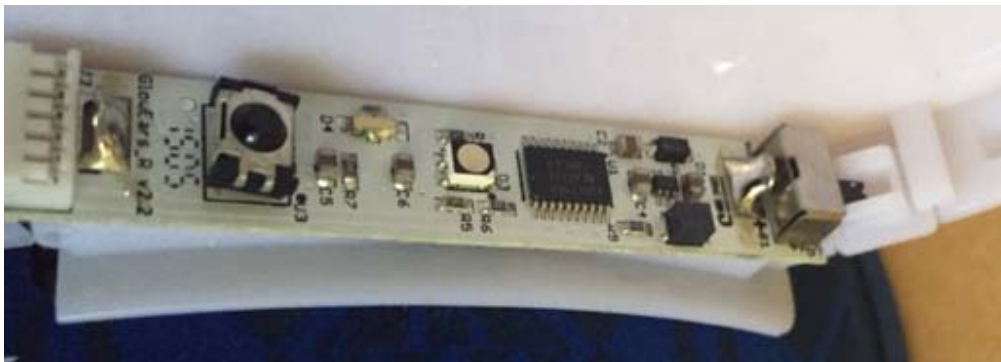
The board in the right ear contains most of the main components:

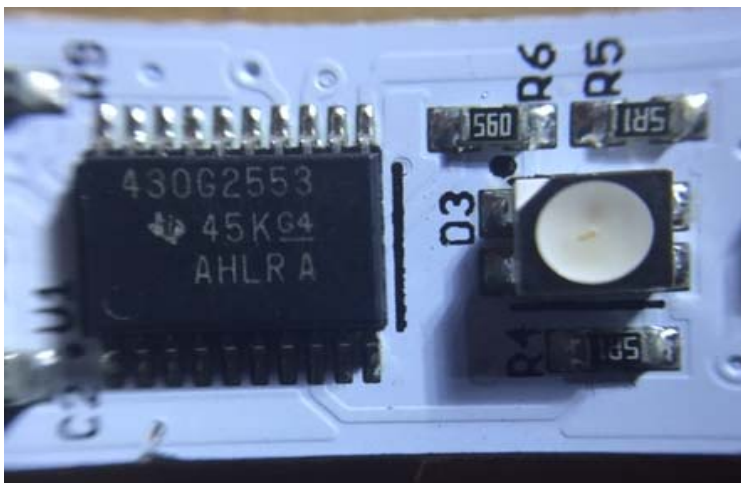
I tried to take some close ups of the various components on that board but the lighting was pretty bad by the time I got around to doing so. It took a while to figure out how best to release the boards from their perches. With that caveat, looks like the processor remains the TI 430G2553:

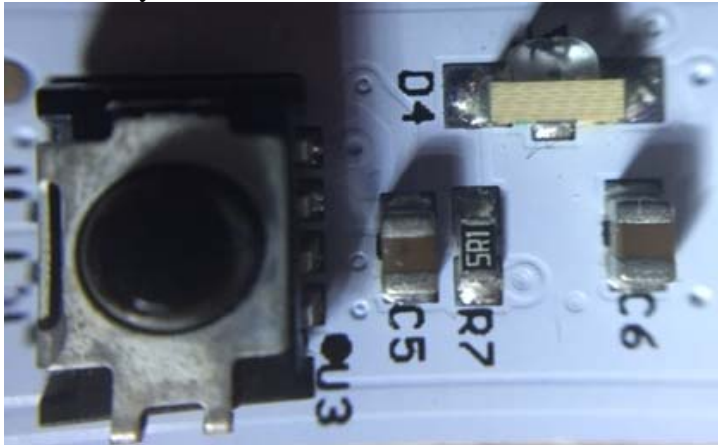
Presumably the IR emitter and receivers:

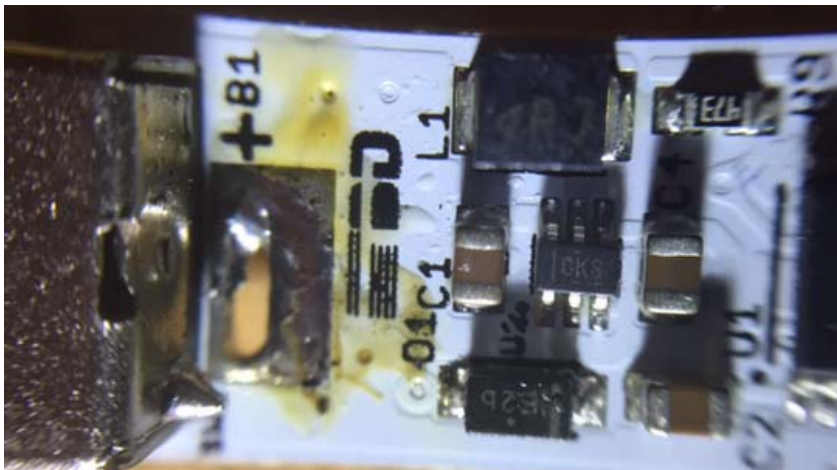
Remaining components on the switch end of the board:

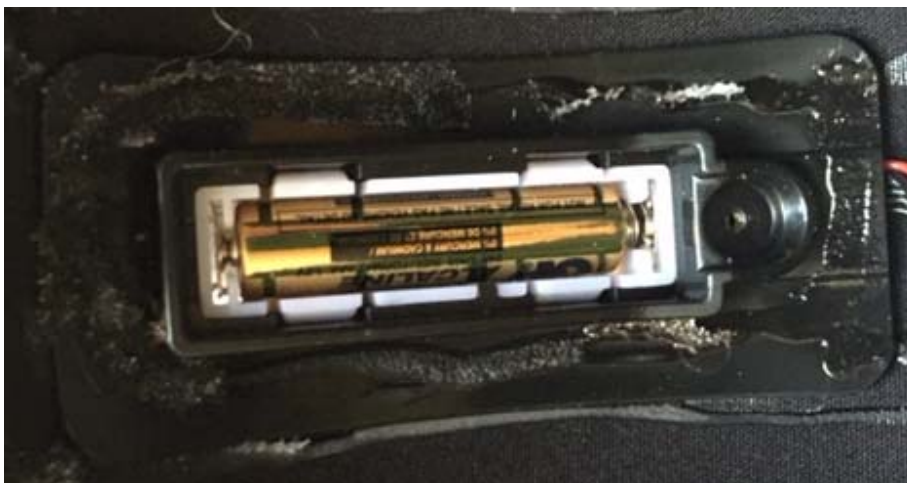
That connector between the two boards connects six wires from each board. One wire is red, the other five are black. The wires and the connector are both heavily glued into place and part of the cable runs between the cap fabric and the black plastic ear support piece. You get a glimpse of that situation on the far right side of this photo:

Freeing that wiring required some careful hat dissection. There doesn't seem to be much hope for an easy means to simply slip the wires through that assembly. Lots of glue. Lots.
